## Failures in Shipping Containers (Updated October 2003)

In 2001 WFF constructed for CREAM a rotational GSE, delivered in 2 crates. One held the gear-box, rotation control, and motor ('**Tall Crate**' below), while the other ('**Long Crate**' below) held the construction elements (steel I-beams) with casters, etc. In 2002, WFF delivered to CREAM the upper and lower sections of the Instrument Support Structure (ISS) in another crate ('**Detector Crate**' below). Significant problems appeared with all three crates.

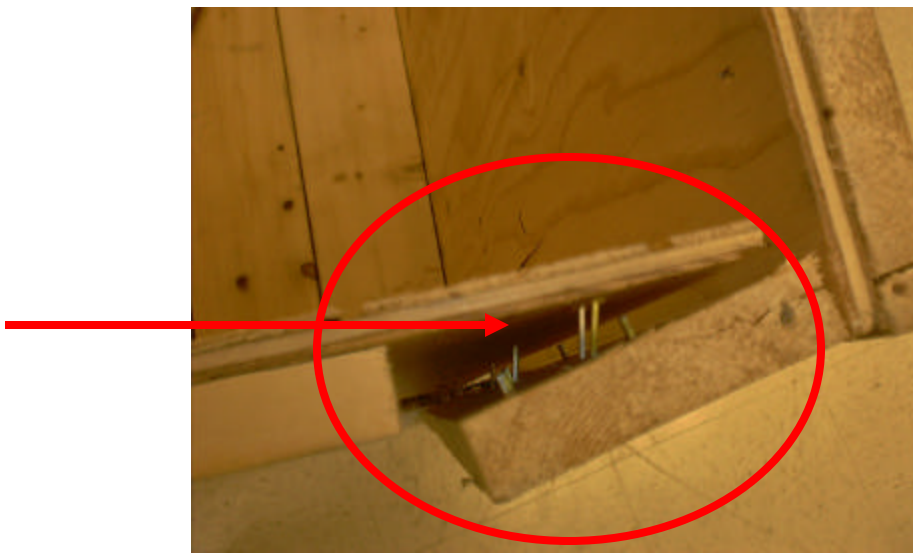
This crate held a total of approximately 650 lbs. of equipment. The sides were made of 3/8" plywood with 1"x4" wood frame members stapled to the plywood, with no glue used. Upon return from CERN in 2002, the staples holding the frame to the plywood on one corner had pulled out (see Fig. 1), and the plywood had torn (see Fig. 2), making the box unusable.

Fig. 1: Staples pulled out on one corner

It is our recommendation that future shipping crates provided to the CREAM project (as well as other projects) be constructed of thicker plywood, with more frame members, and using glue and screws rather than staples and/or nails. In general, such crates should be constructed to be robust enough for multiple trips, taking into account a fair amount of mis-handling by shippers.

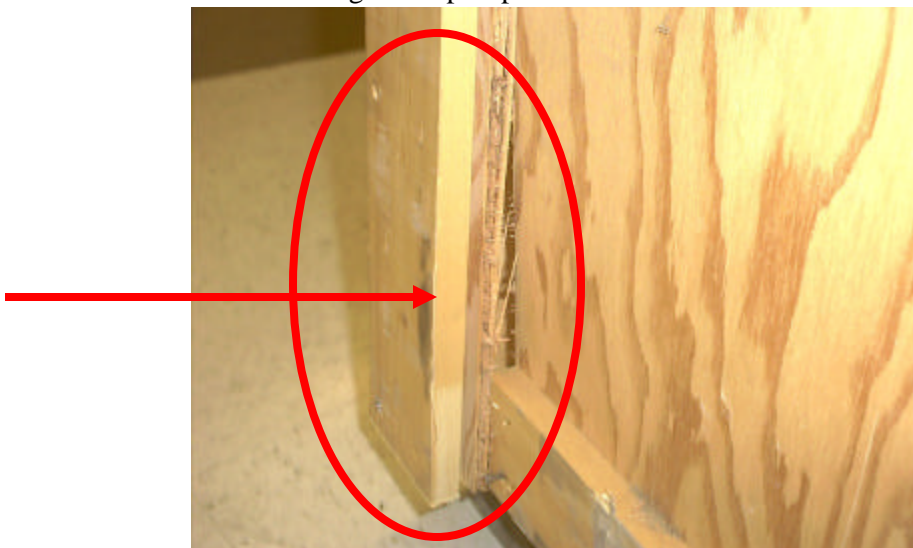
Fig. 2: Plywood torn on one side

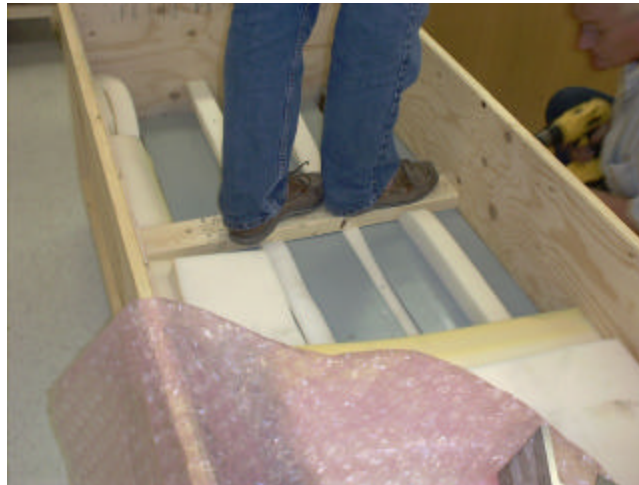
This crate held a total of approximately 1300 lbs. of steel elements, held in place by use of 2"x4" wood sections, screwed to the sides of the crate limiting the up-down motion of the I-beams (see Fig. 3). The sides were made of 3/8" plywood sheets with 1"x4" wood frame members (see Fig. 4), nailed together, with no glue used. Motion of the I-beams along the crate's long axis was only limited by the ends of the crate.

Fig. 3: 2"x4" sections preventing up-down motion of I-beams

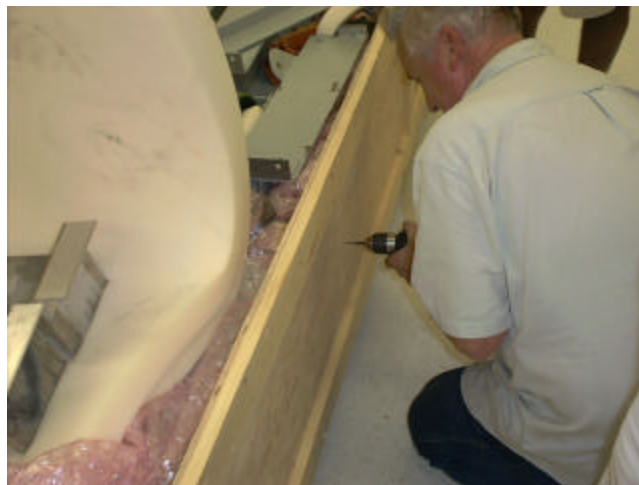
Fig. 4: 3/8" plywood sides with 1"x4" frame members

It is clear from the above that the technique and materials used were inadequate to the stated requirements the crate needed to meet. The crate should have been constructed of  $\frac{3}{4}$ " plywood, with more frame-members than used, with all sides attached using glue and screws rather than nails. While this would have resulted in a more expensive and heavier crate, it would have survived the repeated trans-Atlantic transits.

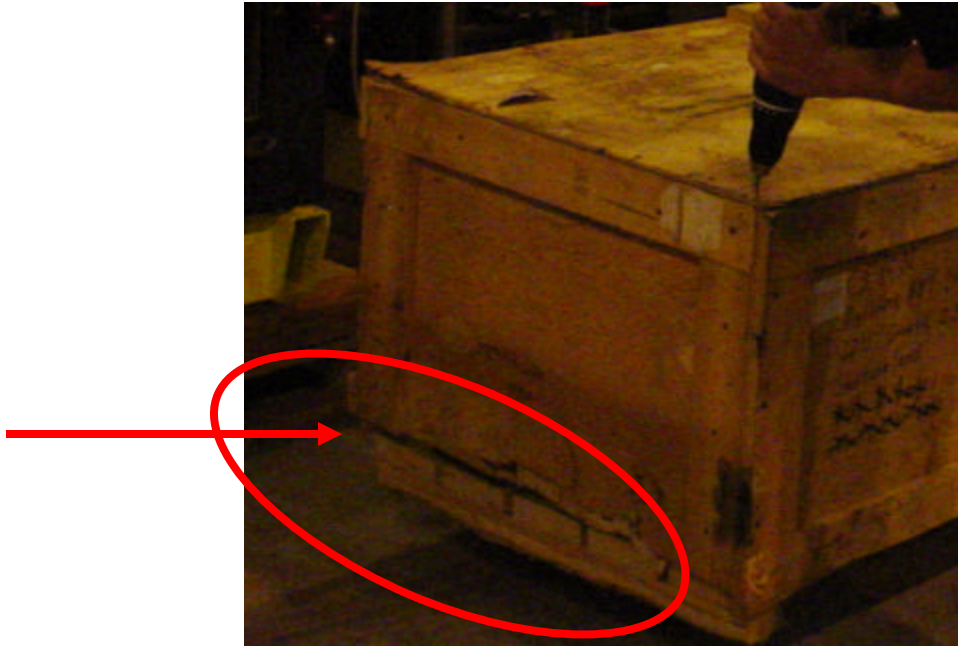
When the Long Crate arrived at CERN in 2001, the ends of the crate were damaged, apparently by the I-beams breaking through the ends during transit. To make the return trip, UMD personnel had to reinforce these sides using 3/4" wood sheets inside the crate. In addition, where the nails holding the crate walls to each other had started pulling out, UMD personnel had to use screws to reinforce the crate. These repairs worked and the crate survived the return trip. However, when the crate was shipped again to CERN in 2002, upon arrival it was found that the nails connecting the crate walls to its bottom had pulled out around most of the crate, and especially at one end. This allowed the crate walls to separate from the bottom of the crate, rendering the crate unusable (see Fig. 5).

Fig. 5: Crate bottom separated from walls

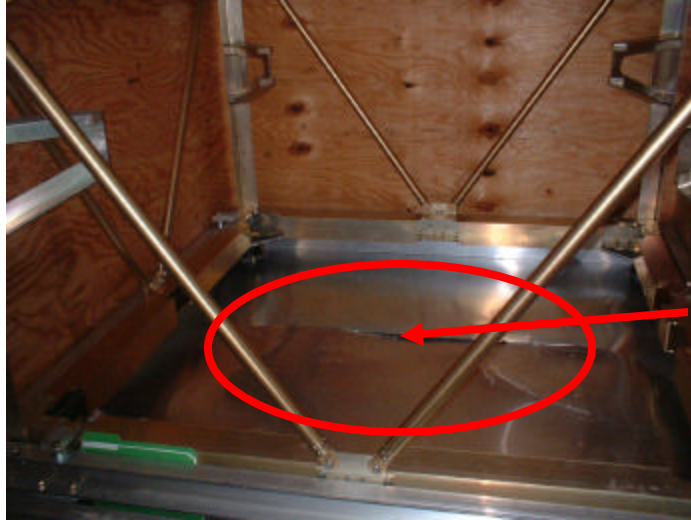
The Detector Crate was made with a 0.030" aluminum bottom cover under an aluminum beam structure, and steel C-channels for fork-lift operations. The C-channels were placed at the correct distance from each other for standard fork-lifts. This did not take into account the fact that the crate would need to be sent to CERN and to McMurdo Station, where along the way it would encounter people who may not know to use the proper size fork-lift. Indeed, at the University of Chicago an attempt was made to lift the crate with a smaller fork-lift, resulting in the aluminum bottom being damaged (see Fig. 6). Luckily, the flight honeycomb pallet was not in the crate at the time, so the only expense and delay were to repair the crate (see Fig. 7). Once the crate arrived at UMD after repairs were completed, UMD added a 1" plywood sheet, reinforced by sections of 4"x4" wood between the two C-channels to prevent similar damage in the future (see Fig. 8). While at CERN, had UMD personnel not intervened, the CERN Shipping Dept. personnel would have used a similar small fork-lift to assist in off-loading the detector crate from a truck. Following this intervention the CERN Shipping personnel arranged for the correct size fork-lift to be brought in and used.

Fig. 6: Aluminum bottom of crate broken through

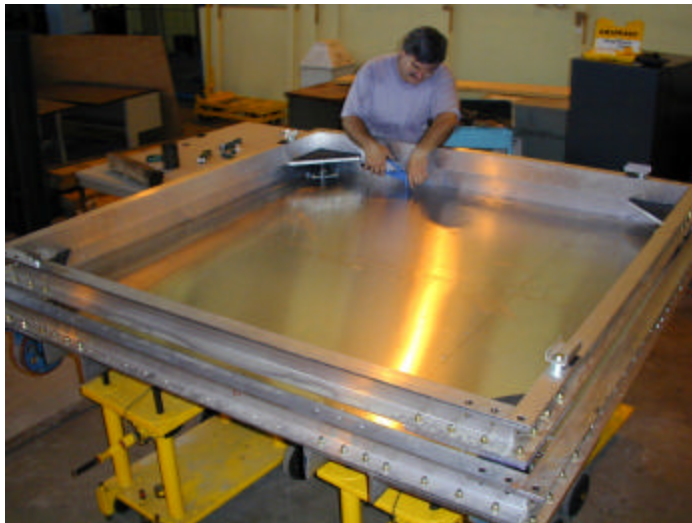
Fig. 7: Repair of aluminum bottom

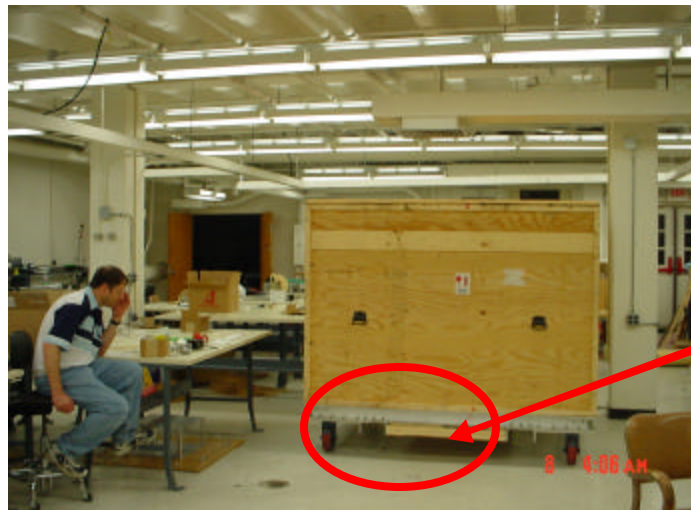
Fig. 8: Wood support bolted between the C-channels at the bottom of the crate

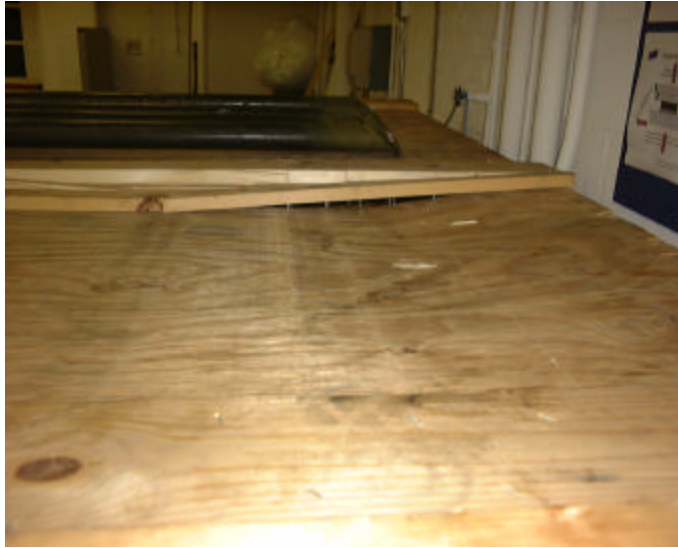
In September 2003, on the way back from CERN the top of the detector crate was damaged in a manner consistent with someone having placed another crate on top, which started breaking through the plywood top and 1"x2" frame member (see Figs. 9 and 10 for views from outside the box and from inside the box).

Fig. 9: Top of detector crate damaged (outside view)

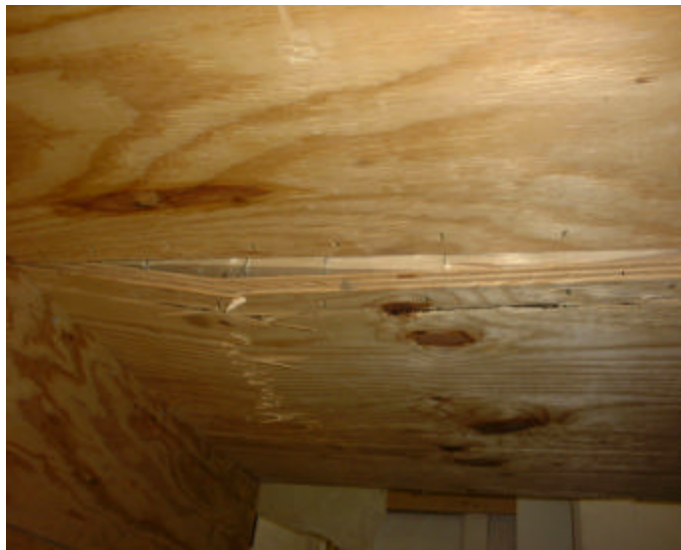
Fig. 10: Top of detector crate damaged (inside view)
